## Marriott Marquis® Hotel

**Building Type** Commercial Hotel  
**Space type** Lobby & Lounge  
**Location** New York, NY

## Enhance Sound Clarity with AcoustiBuilt®

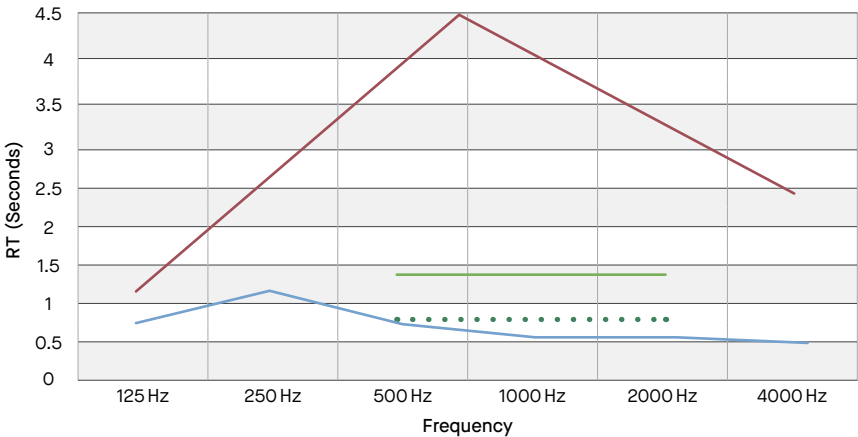
Lobby

Conditions

Room: Estimated Area of 2900 SF  
Average Ceiling Height 14'

Surface finishes:

- Floor: Marble
- Walls: Drywall & Glass
- Ceiling: Drywall (baseline)

Ceiling/Deck Treatment	Drywall	AcoustiBuilt
Amount (SF)	2900 SF	2900 SF
Reverberation Time (RT)	4.26 seconds	0.65 seconds

The original drywall ceilings and hard-surface finishes which resulted in excessive reverberation — measured in at 4.26 seconds in the lobby and 3.18 seconds in the lounge. These values far exceeded the recommended reverberation time range for such spaces, which should ideally fall between 0.6 to 1.4 seconds.

AcoustiBuilt ceilings reduced the reverberation time to 0.66 seconds in the lobby and 0.55 seconds in the lounge — an 85% and 83% improvement, respectively. These results demonstrate that with the correct acoustic analysis, you can significantly enhance speech clarity, reduce noise, and contribute to a more comfortable and inviting environment for hotel guests and staff. The seamless aesthetic of AcoustiBuilt also offers a clean monolithic visual without compromising acoustic performance.

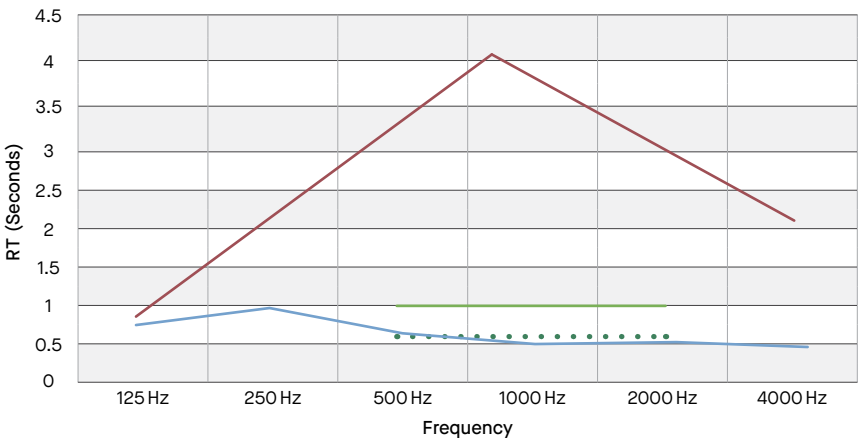
Lounge

Conditions

Room: Estimated Area of 1500 SF  
Average Ceiling Height 12'

Surface finishes:

- Floor: Vinyl
- Walls: Drywall & Glass
- Ceiling: Drywall (baseline)

Ceiling/Deck Treatment	Drywall	AcoustiBuilt
Amount (SF)	1500 SF	1500 SF
Reverberation Time (RT)	3.18 seconds	0.55 seconds

● Maximum Target ● Preferred Target ● AcoustiBuilt ● No Treatment
